Technical Letter  
No. 1110-2-286

25 July 1984

Engineering and Design  
USE OF GEOTEXTILES\* UNDER RIPRAP

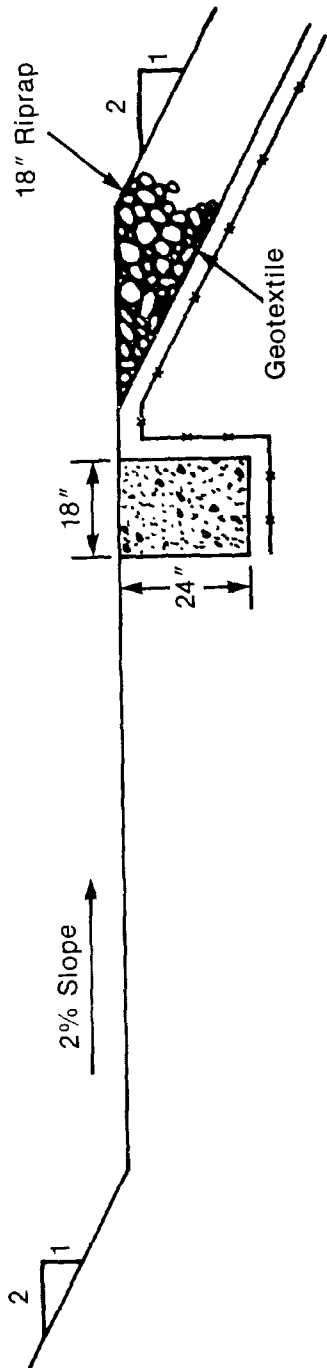
FIGURE 1. Entrenched Geotextile at Top of Slope.

c. Placing the upper end of the geotextile in a trench at the top of slope was found to be a good practice to help control surface runoff. However, if the trench was backfilled before the bedding or riprap was placed, the geotextile was stretched tight and became more susceptible to puncturing and tearing.

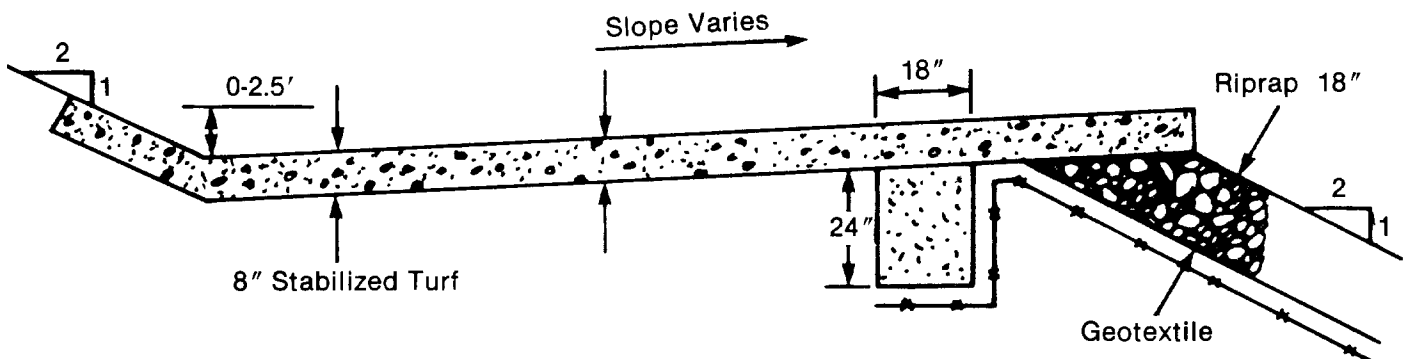
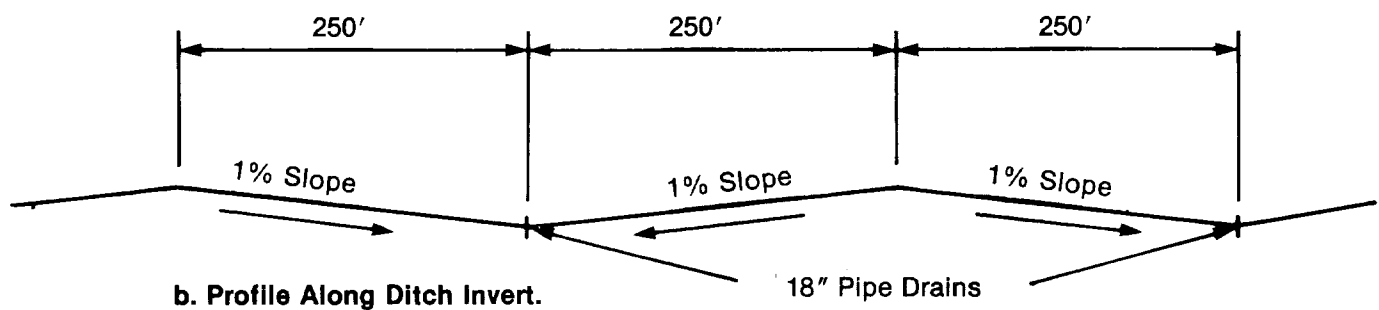
**FIGURE 4. Typical Surface Water Collector System.**

11. Surface Water. Failure to properly handle surface water resulted in many failures. The concept of sheet runoff was used in design but this proved to be inapplicable since the runoff tended to create channels in the highly erodible soils and undermine the geotextile. The geotextile was either clogged, of too low a permeability, or not in contact with the soil, causing the water to percolate down the slope under the geotextile instead of up through the textile and then down the slope on top of the textile. Any punctures or tears in the textile allowed the trapped water to exit and carry materials with it. Slumps or depressions in the riprap resulted, and in cases of heavy or prolonged rainfall, a complete washout and failure occurred. Burying the geotextile 2-3 feet deep in a trench at the top of slope after riprap placement helped greatly to control erosion, but it was not a complete solution (Figure 1). Modifying berm slopes and stabilizing berms with small rock were also tried and met with varied success (Figures 2 & 3). Collector systems for the runoff proved to be the best and most reliable overall solution but were expensive. Various combinations of ditches, paved channels, and pipes were used successfully. Figure 4 shows a typical collector system. See Inclosure 1 for Figures 1 thru 5.

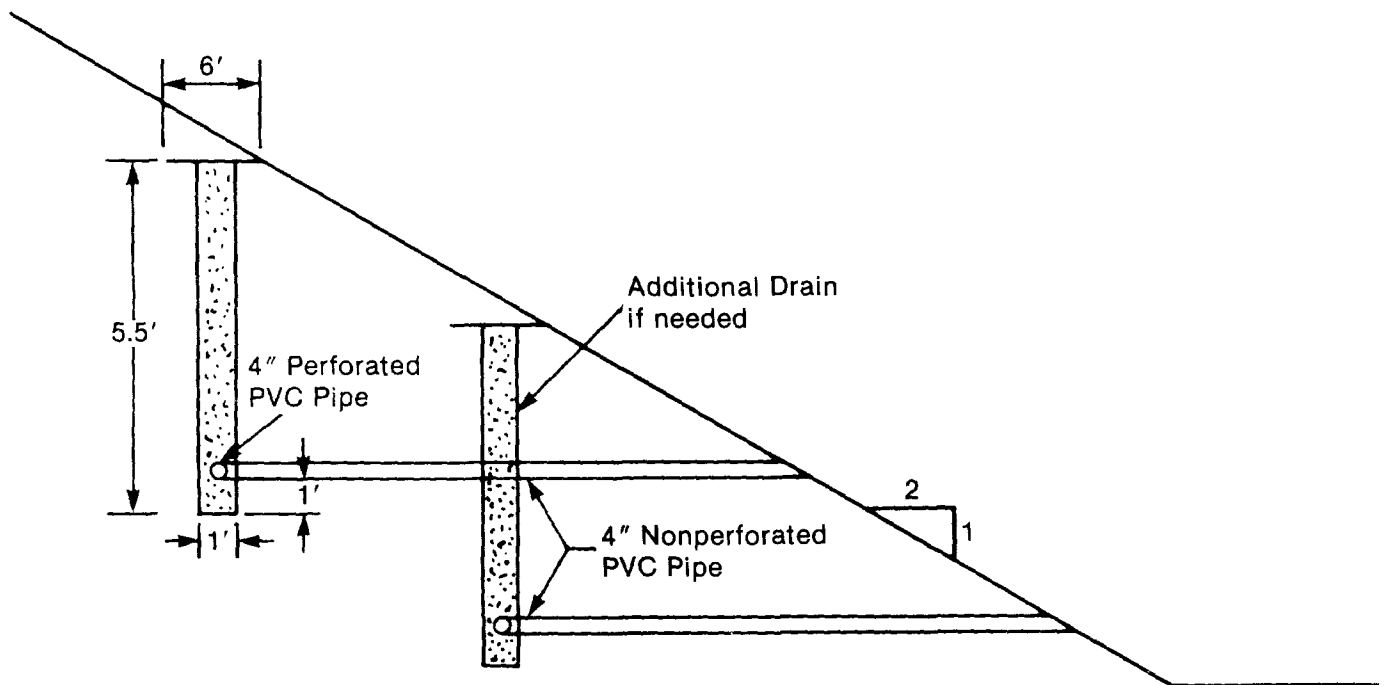
**FIGURE 5. Typical Lateral Drains for Groundwater Seepage Control.**

12. Groundwater. Groundwater seeping out of cut slopes also presented problems. Coupled with the highly erodible and horizontally laminated soils, the groundwater seepage eroded the slopes badly and created soft unstable areas. Extensive slope preparation was required to correct the erosion problem. Interceptor trench drains parallel to the waterway center-line were required to stabilize the slopes before the geotextile and riprap could be placed. These drains were installed as determined in the field, with as many as six lines of drains needed on a single slope. Figure 5 is a typical section of these drains.
